# Manhole Inspection Summary

Manhole # S35Q1\_001MH

**Location** Address: **701 Cherryland Rd. (in the woods east of Reedbird)** Cross Street: **Reedbird Ave.**

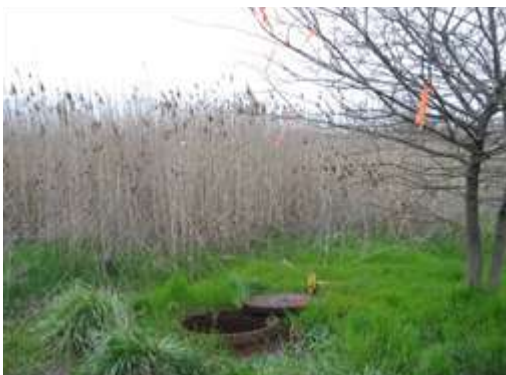
Location View

701 Cherryland Rd. (in the woods)

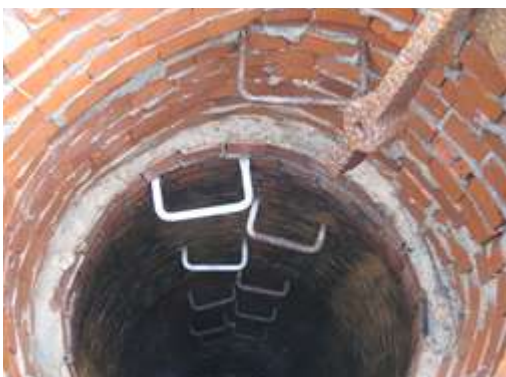
Steps

**Steps** Count: **17** Missing: **0** ☒ Corroded

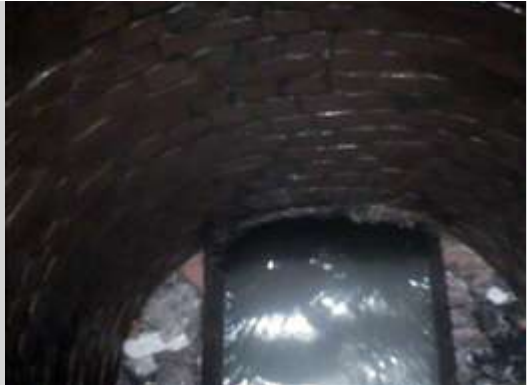
12 O'Clock Outflow

30 in. Circular Gravity Sewer  
Pipe Out @ 12 O'Clock

Pipe Height: **3.6** (in.) Rod and Bar (Angled)  
Pipe Material: **Concrete** ☐ Pipe Lined  
Invert Depth: (ft.) Flow Characteristics: **Fast**  
Deposits: ☒ None ☐ Mud ☐ Sludge ☐ Debris ☐ Grease  
Silt Depth: (in.) Deposits Extent:  
Infiltration: **None** Pipe Seal Cond: **Sound**

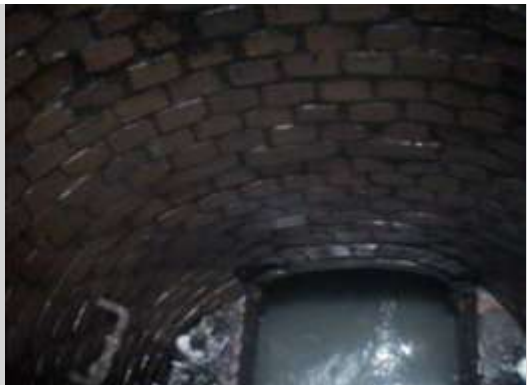
6 O'Clock Inflow

30 in. Circular Gravity Sewer  
Pipe In @ 6 O'Clock

Pipe Height: **3.6** (in.) Rod and Bar (Angled)  
Pipe Material: **Concrete** ☐ Pipe Lined  
Invert Depth: (ft.) Flow Characteristics: **Fast**  
Deposits: ☒ None ☐ Mud ☐ Sludge ☐ Debris ☐ Grease  
Silt Depth: (in.) Deposits Extent:  
Infiltration: **None** Pipe Seal Cond: **Sound**
